Dredging Projects (2016)

Coastal Vulnerability Index East River - Moriches Bay Watershed, NY

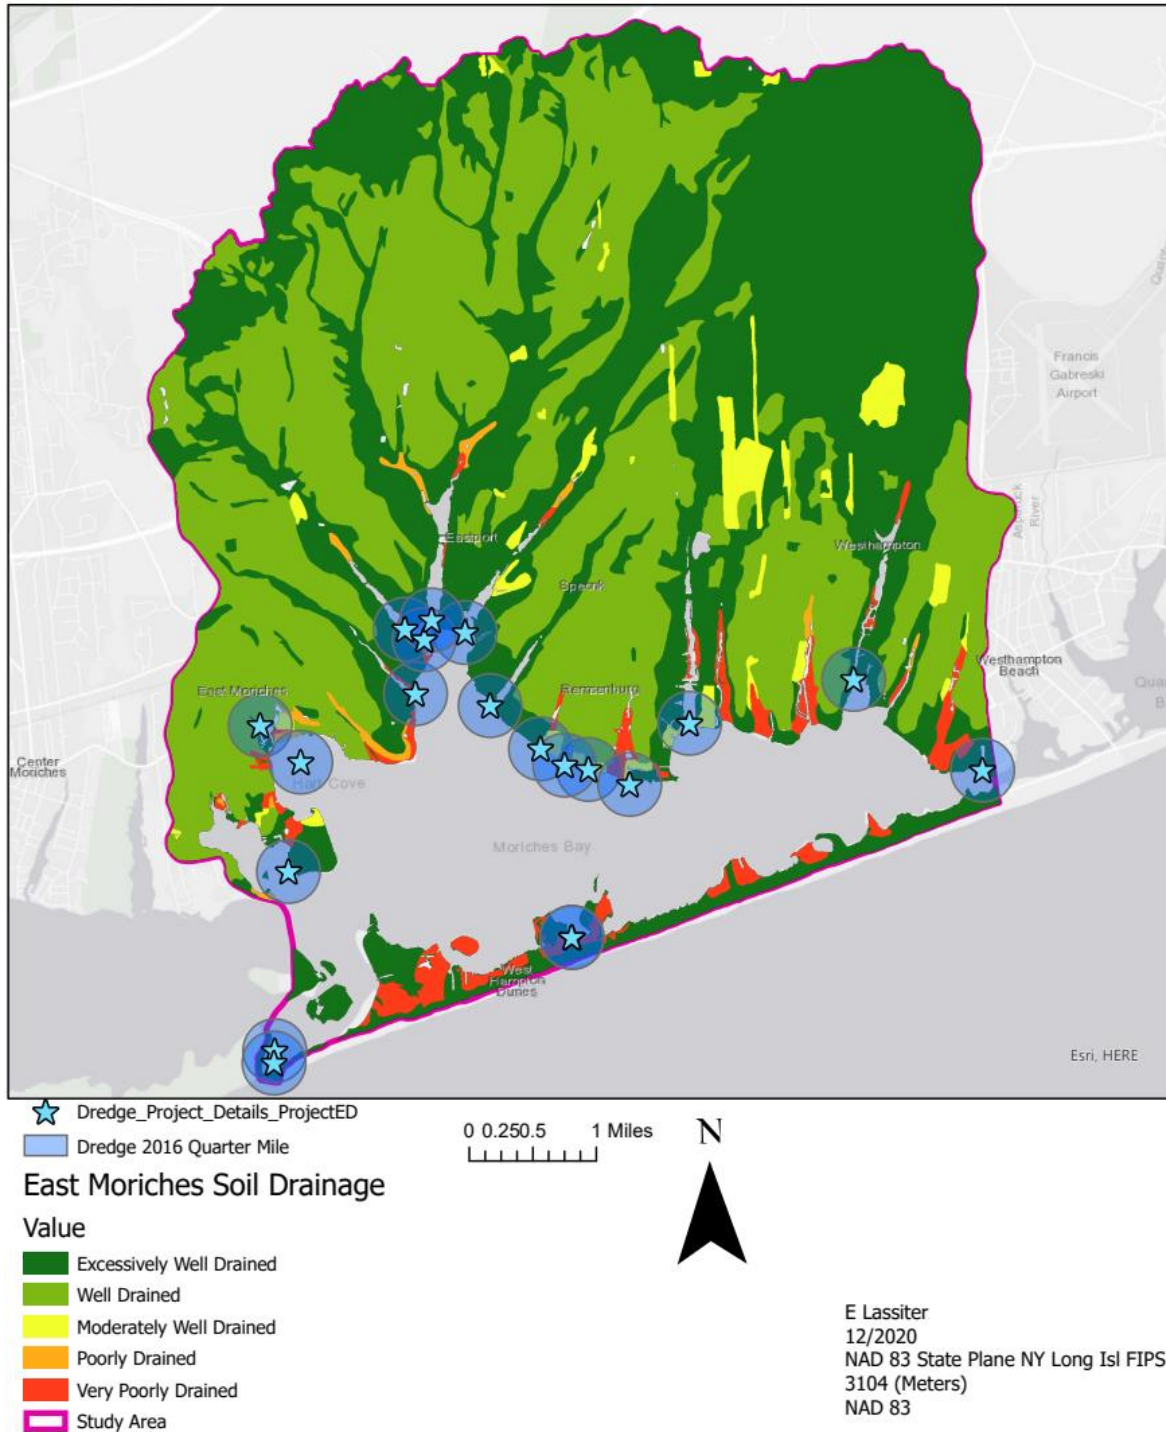
Figure 1: A map of the dredging projects undertaken in 2016 and their effects on the subsequent drainage patterns in the East River - Moriches Bay, New York. The light blue stars and the quarter-mile circles around them represent the locations dredged.

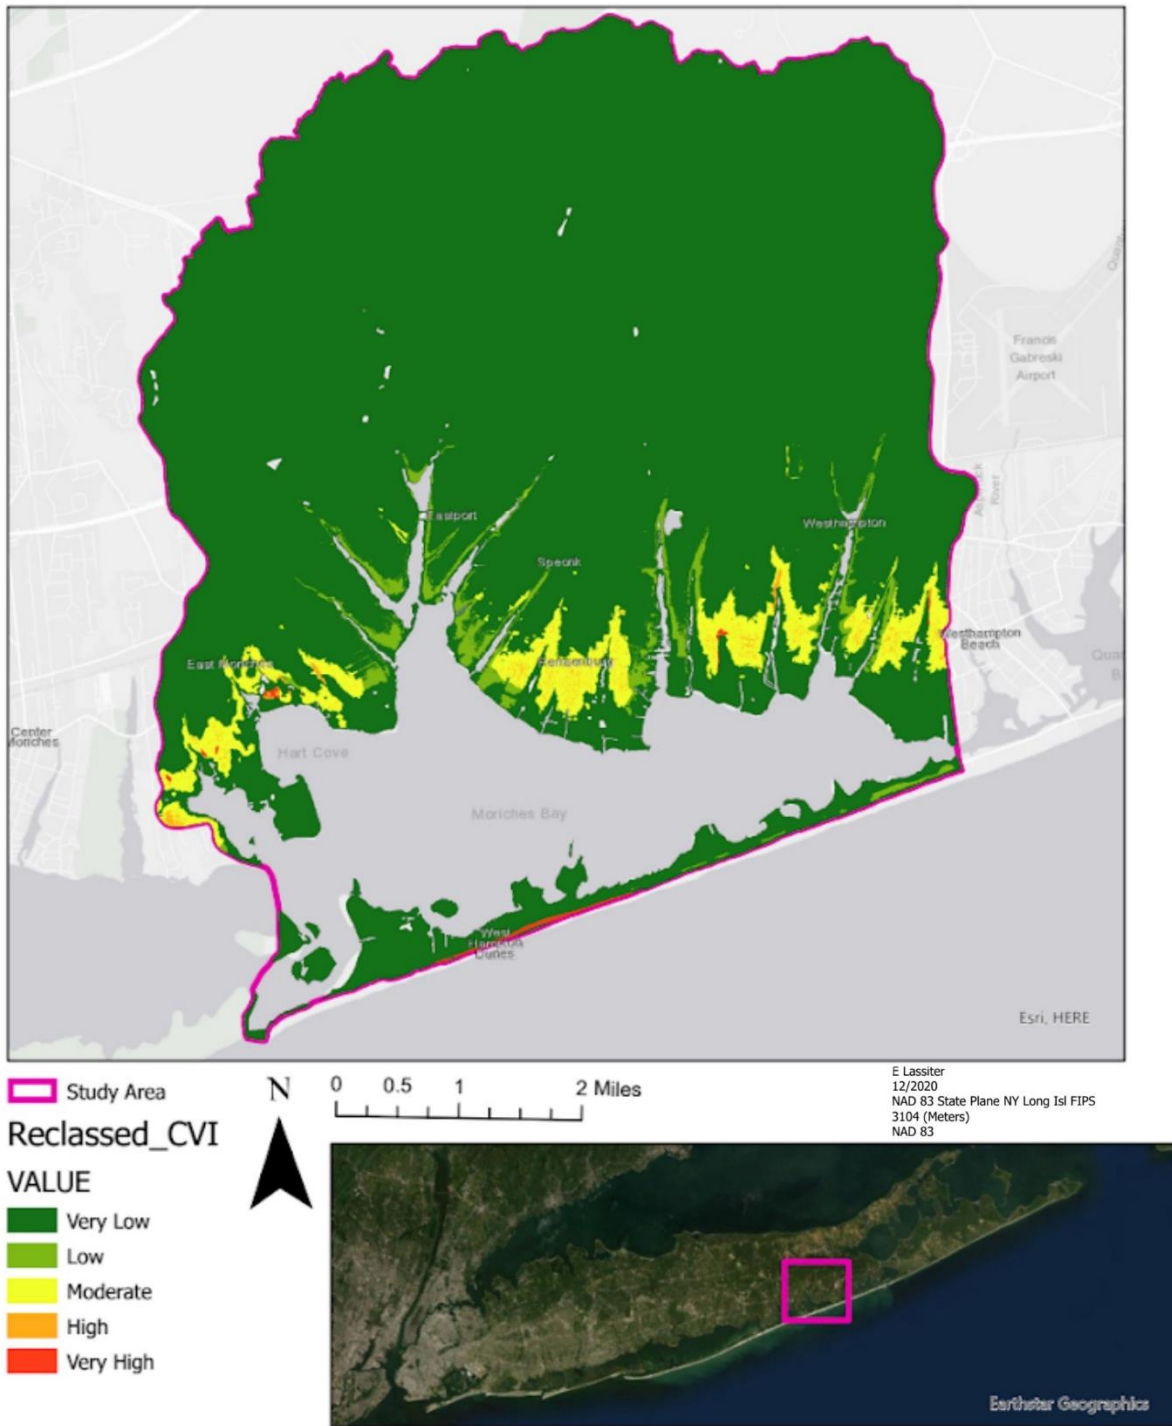
Figure 2: A Coastal Vulnerability Index (CVI) map of the East River – Moriches Bay, New York. Some areas of concern are densely populated and under further development.
